Brushy Creek Stream Stabilization

Greenville County, SC

Project Overview

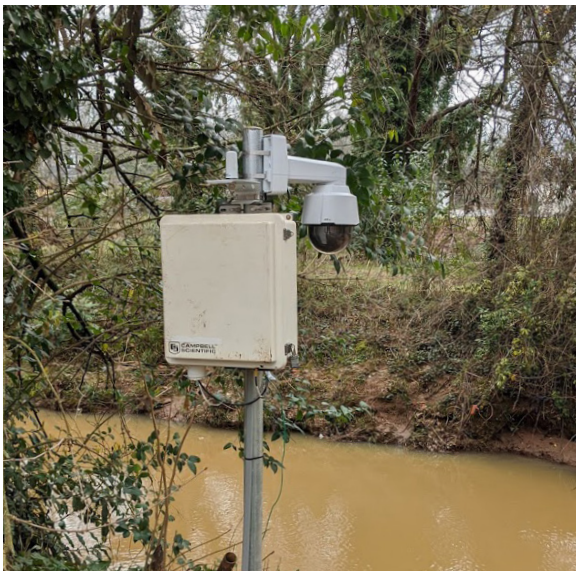
Figure 2. Mills Avenue camera.

Throughout construction of the stabilization techniques, industry safety measures, including workers' constant use of the appropriate protective gear, were closely observed. A live camera feed (Figure 2) used for documenting installation provided an extra layer of accountability to ensure all team members followed appropriate safety protocols.

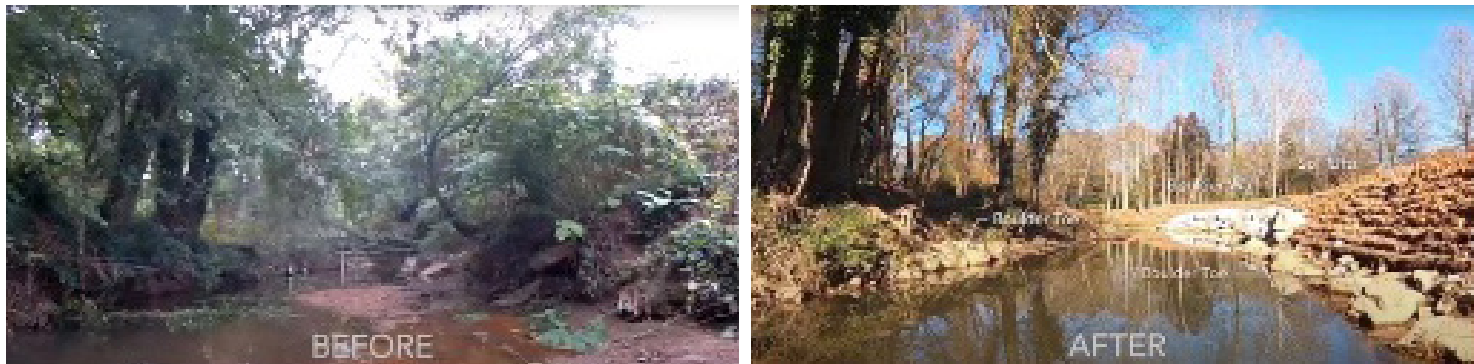
Figure 3. Brushy Creek before and after the implementation of boulder toe walls and soil lifts.

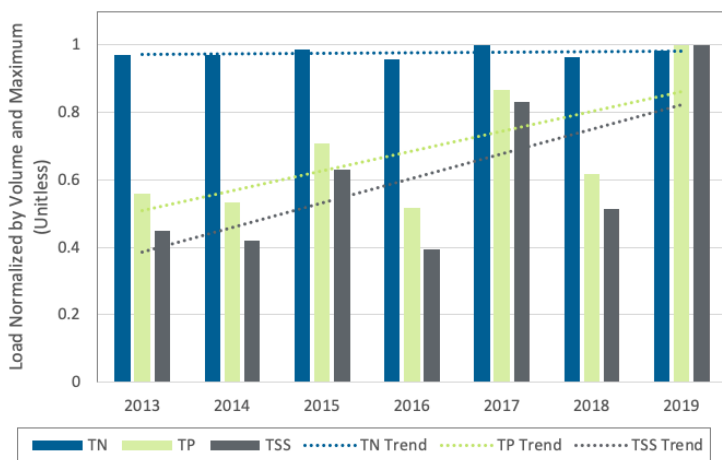
Figure 4. Pollutant loading within Brushy Creek at Mills Avenue since 2013.

Greenville County was able to take environmental protection a step further by quantitatively monitoring the area water quality before and after implementing the chosen stabilization techniques. Figure 4 displays this nutrient data collection. As this site stabilizes and additional monitoring data is recorded, the County will be able to assess the impacts of the project on long-term pollutant loading. For seven years, the County has collected water quality data for pH, turbidity, dissolved oxygen, and specific conductivity coupled with discrete grab samples for bacteria and nutrient concentrations (Figure 5). In the last four years, the stabilized reach of Brushy Creek has displayed increasing concentrations of total nitrogen and total phosphorus, while its concentration of total suspended solids has remained consistently high. These numbers are expected to substantially decrease as the newly planted vegetation establishes. The materials and methods used along Brushy Creek will be monitored for longevity, form and function on a long-term basis.

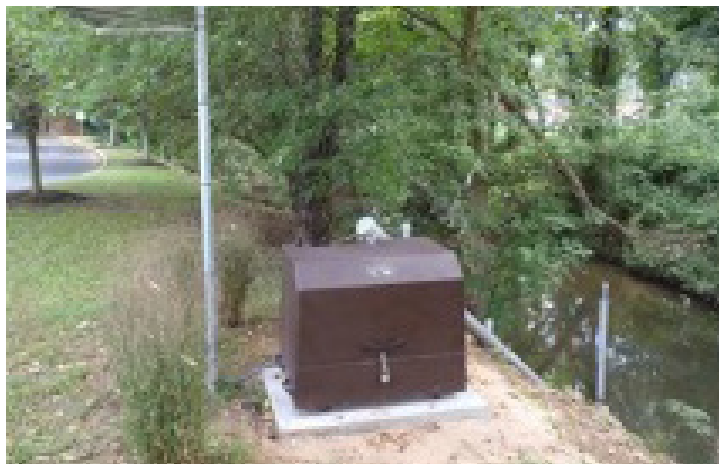
Figure 5. Greenville County monitoring station at Mills Avenue.

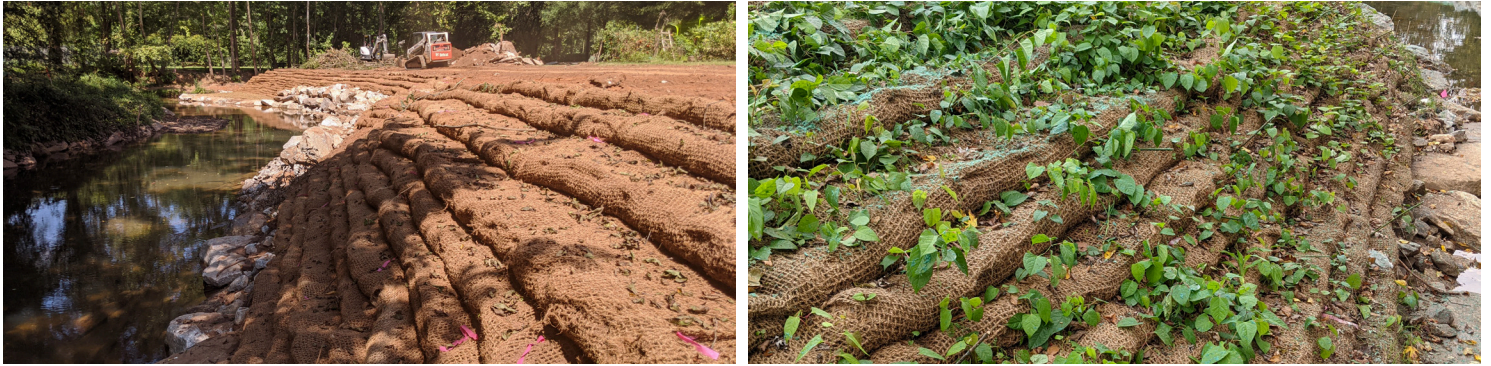
Thorough environmental stability requires continual post-construction inspection. Within a few weeks of completion, invasive Japanese knotweed overtook the soil lifts on site (Figure 6). Invasive species such as these decrease the biodiversity of an ecosystem and can increase soil erosion. A certified herbicide applicator was contracted to remove the knotweed under the direction of Woolpert-certified managers of invasive species. The County will inspect the area for invasive species twice in the next year to ensure these species are not inhibiting the design and establishment of native species.

Figure 6. Soil lifts immediately following construction (left) and Japanese knotweed invasion of the soil lifts (right).

As previously stated, the abundance of invasive species in the area threatened the longevity of design efficacy at the completion of construction. Maintenance agreements drafted between the County and the contractor addressed this issue, ensuring the site will receive continued inspection. Even further, the prevalent and very active beaver population damaged the initial plantings, requiring additional protection measures such as adding tree cages and acquiring assistance from animal control specialists.

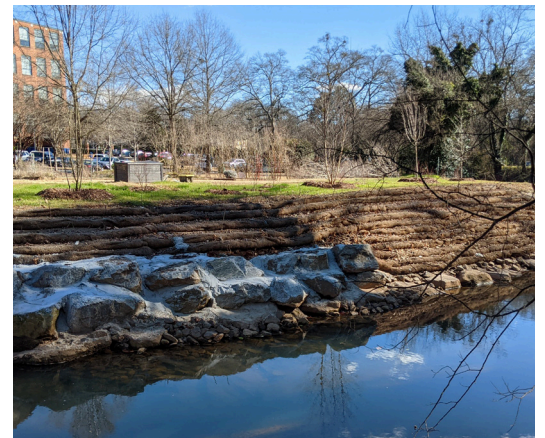
Figure 7. Brushy Creek after the implementation of boulder toe walls and soil lifts.

The project team considered the accessibility of this area to the community when choosing stabilization techniques. Strategies selected for the reach of Brushy Creek appear more natural than other forms of bank stabilization once native species populate them (Figure 7). The inclusion of several techniques like these provide the perfect opportunity to educate the public about the importance of soil conservation. Ultimately, property owners were very happy with the final enhanced version of the creek.

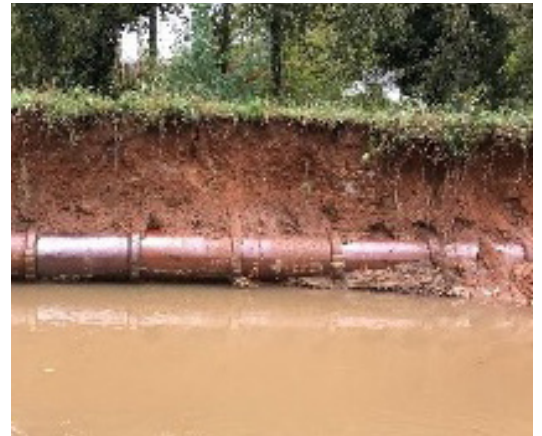
Figure 9. ReWa sewer pipeline exposed due to stream degradation.

Large rain events, like those which impacted the area throughout construction, have been particularly acute since 2015. The resulting significant bank erosion and consequential exposed gravity sewer line (Figure 9) that solicited need for this stabilization project made the installation of bank protection very difficult. Nonetheless, the excavation and installation of several areas of exposed pipe were performed successfully thanks to a dedicated construction crew.

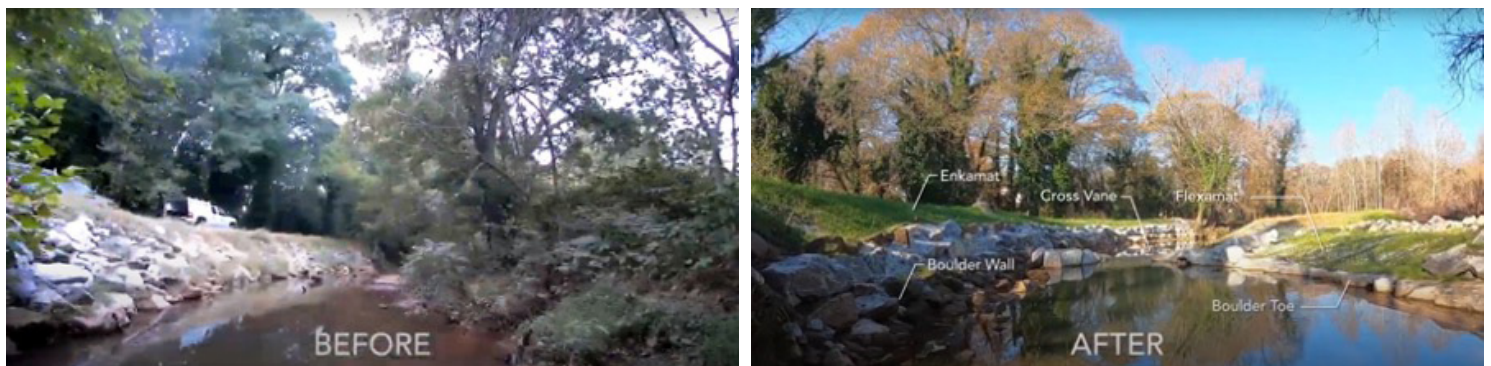
Figure 10. Flexamat.

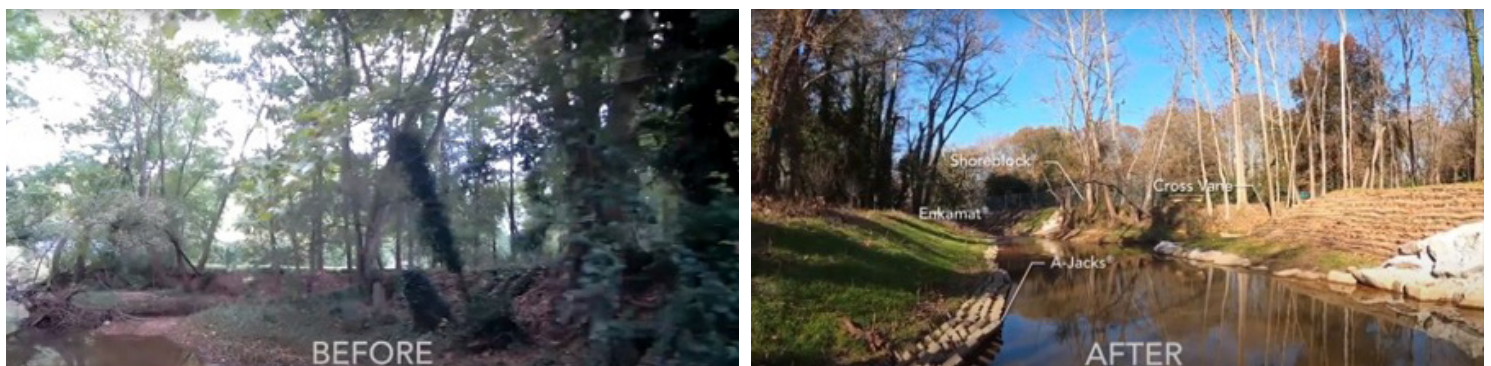
Figure 11. A-jacks.
